RZR 570 BLOW HOLE INSTRUCTIONS

APPLICATION: POLARIS RZR 570 - ALL

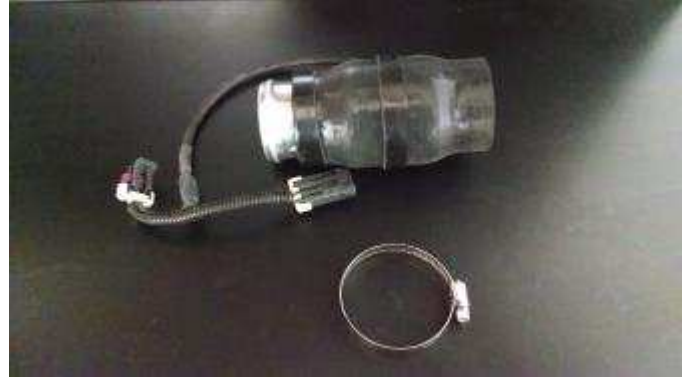
1. REMOVE SEATS AND REAR PANEL. LOCATE THE CLUTCH INTAKE DUCT AS SHOWN AND MARK THE HOSE END THAT GOES ON THE CLUTCH HOUSING (YOU WILL NEED TO KNOW THIS SO YOU CAN CUT THE RIGHT END OFF). REMOVE THE HOSE CLAMPS THAT HOLD BOTH ENDS ON AND SAVE THE CLAMPS.

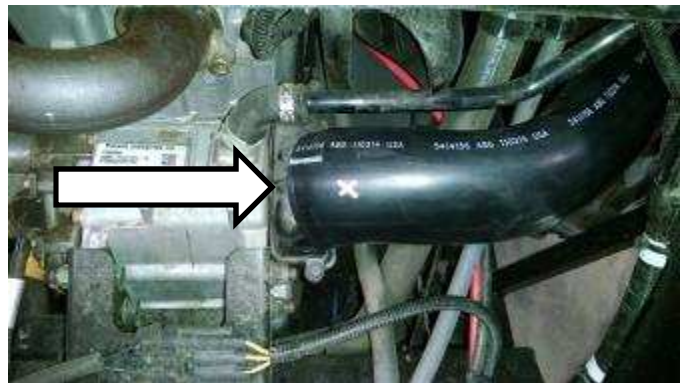
2. LAY THE HOSE DOWN AND MEASURE ON THE OPPOSITE END THAT WAS MARKED PREVIOUSLY. MARK CUT LOCATION OF THE HOSE @ 5-1/4". CUT THE HOSE CLEANLY WITH A HEAVY PAIR OF SHEARS OR WITH A RAZOR KNIFE.

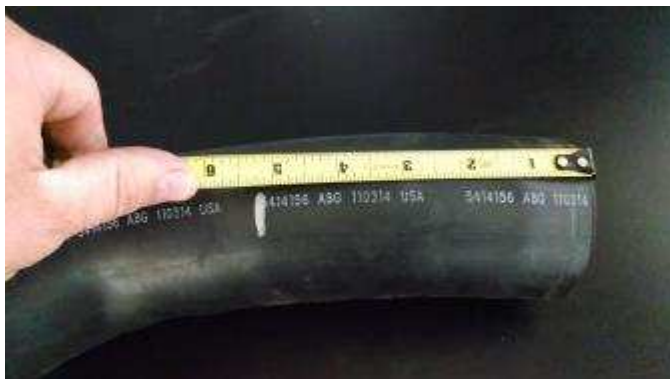
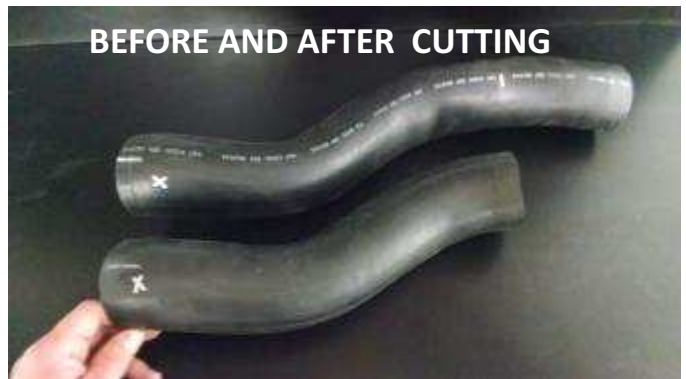
3. TEST FIT THE BLOW HOLE MOTOR ASSEMBLY WITH THE SILICONE HOSE END ONTO THE FENDER AIR DUCT. MAKE CERTAIN YOU DO NOT PUSH THE MOTOR ON SO FAR THAT THE FAN BLADES CONTACT THE DUCT. WE HAVE FOUND THAT THE CHASSIS ELECTRICAL CONDUIT AND IGNITION WIRE COMING OUT OF THE COIL QUITE OFTEN NEED TO BE RE-ROUTED TO ALLOW THE MOTOR TO FIT UP PROPERLY. ON MANY MACHINES YOU SIMPLY JUST PULL THE RED BOOT END OF THE IGNITION WIRE OUT OF THE COIL AND MOVE WIRES AROUND THE COIL. THEN REPLACE THE IGNITION WIRE FULLY. THIS WILL GIVE YOU ROOM FOR THE MOTOR ASSEMBLY TO FIT UP PROPERLY. NOW YOU CAN PLACE THE OEM HOSE THAT WAS TRIMMED IN PLACE. THE HOSE MAY BE ROTATED DOWN SLIGHTLY FROM THE FACTORY MOUNTING TO THE CLUTCH COVER (SHOWN BY THE MARK WE PLACED PREVIOUSLY). ROTATE THE HOSES AND THE MOTOR ASSEMBLY UNTIL THE WIRE IS IN AN ACCEPTABLE PLACE AND THE HOSES HAVE NO KINKS. PLACE THE ORIGINAL CLAMPS ON THE CLUTCH HOUSING AND THE LOWER MOTOR ASSEMBLY CONNECTION. PLACE THE PROVIDED HOSE CLAMP ON THE AIR DUCT CONNECTION.

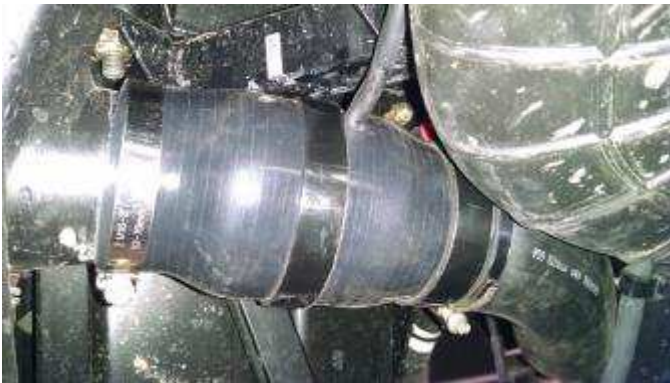
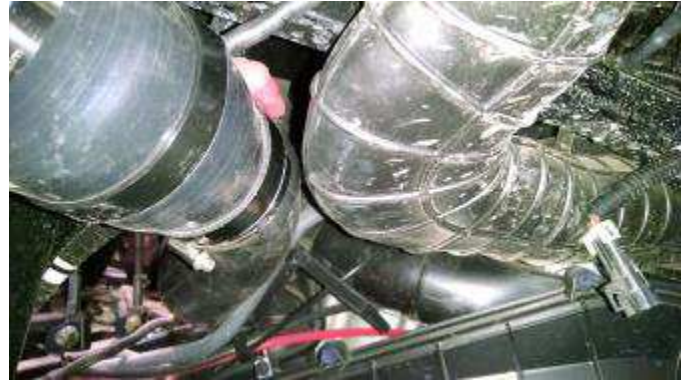
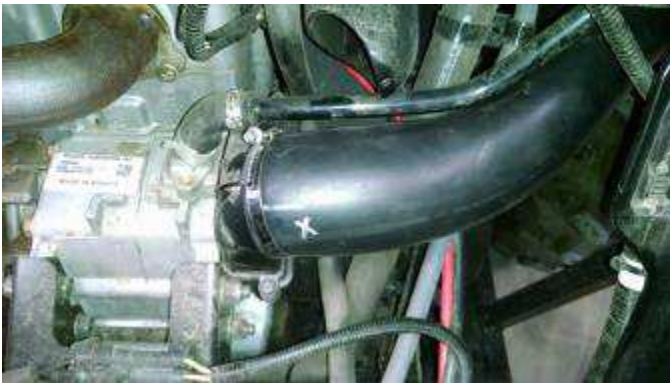
4. LOCATE THE TAILLIGHT WIRE CONNECTION BETWEEN THE BED AND FRAME. CONNECT THE BLOW HOLE HARNESS IN LINE AS SHOWN AND THEN TUCK THE WIRES BACK UP INTO POSITION. RESTRAIN THE WIRES SUFFICIENTLY TO PREVENT THEM FROM COMING LOOSE AND FALLING OUT OF LOCATION.

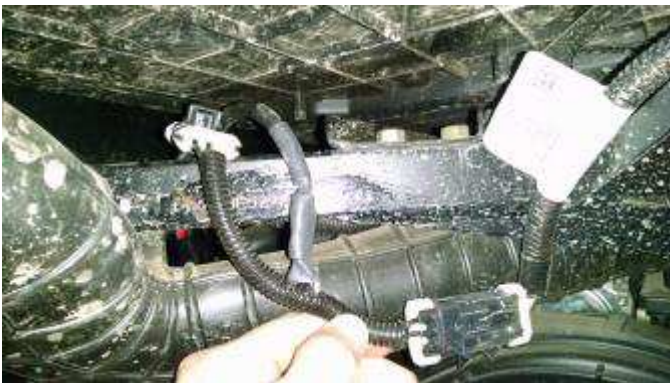
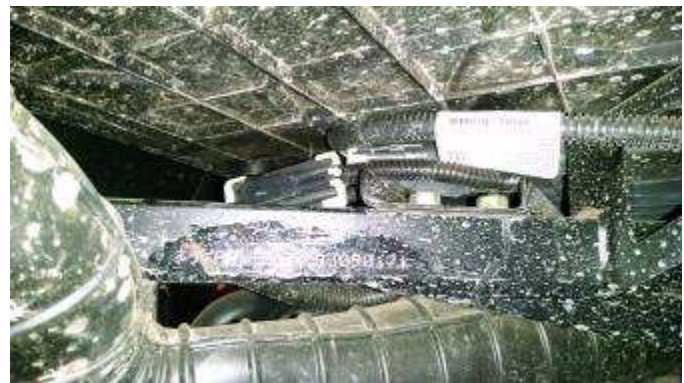
5. ENSURE THAT ALL WIRES ARE SECURED, HOSE CLAMPS ARE TIGHTENED AND THAT YOU HAVE REASSEMBLED THE RZR APPROPRIATELY. TEST THE BLOW HOLE BY TURNING ON THE KEY SWITCH. YOU SHOULD BE ABLE TO HEAR THE FAN RUN. IF IT DOES NOT RUN CHECK THE CONNECTIONS AND FUSES TO THE TAILLIGHTS. TO CHECK IF YOUR HARNESS HAS POWER, DISCONNECT THE FAN AND HOOK THE TAILLIGHTS BACK UP STOCK AND THEY SHOULD LIGHT UP. IF FOR ANY REASON THE WIRING ON THE BLOW HOLE IS SUSPECT OR IF THE FAN MOTOR DOES NOT SEEM TO BE WORKING CORRECTLY, THIS WOULD BE THE PROPER PROCEDURE TO ELIMINATE THE FAN MOTOR UNTIL A PROPER DIAGNOSIS CAN BE DETERMINED. CALL IF YOU HAVE ANY QUESTIONS.
